External Sprinkler Systems and Defensible Space: Lessons Learned from the Ham Lake Fire and the Gunflint Trail

A report prepared for the Firewise Program,
Minnesota Department of Natural Resources
April 15, 2008

Executive Summary

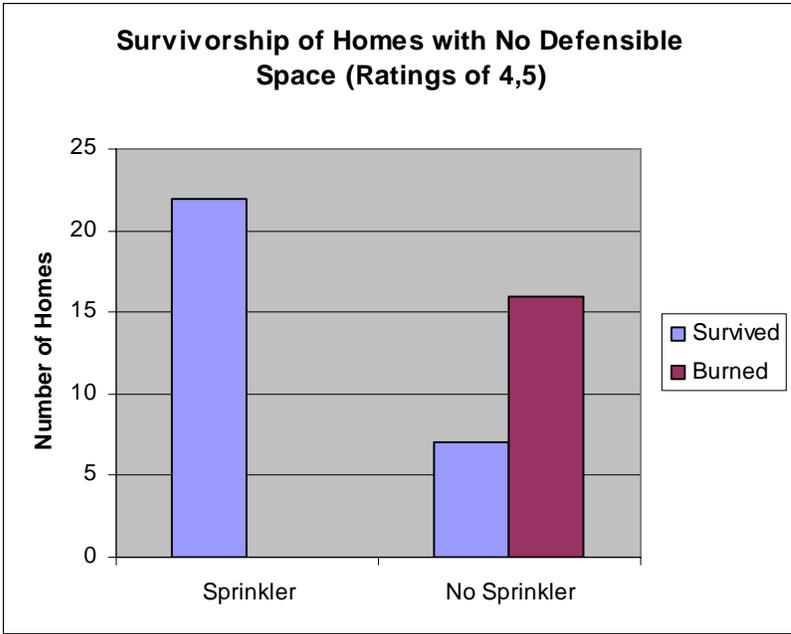
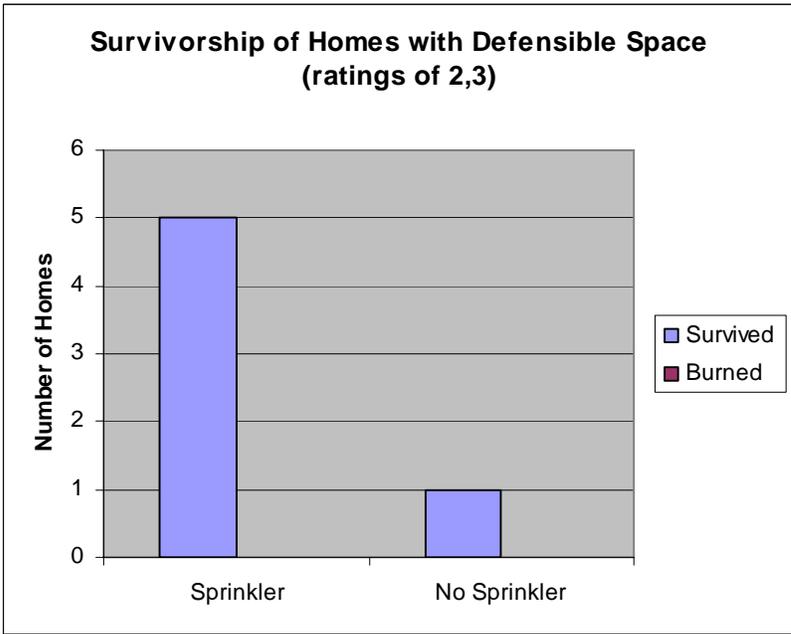
Figure 1: House survivorship by defensible space and sprinkler presence, Ham Lake Fire, along the Gunflint Trail 2007.

Of the 51 houses that were located in the Seagull Lake area, 16 were burned by the fire and 35 survived. The majority of these homes were classified as Level 5-High Risk houses based on the Firewise rating of defensible space. Thirty-eight houses scored a 5; seven scored a 4; five scored a 3; one house scored a 2; and there were no houses that scored a 1. None of the houses that burned had any significant defensible space (i.e., they scored a 4 or 5).

In comparison with sprinkler systems, of the houses that burned, five had sprinkler systems, but all of those failed. Of the houses that survived, only eight did not have working sprinklers, and only one of these had any significant defensible space (i.e., 2 or 3).

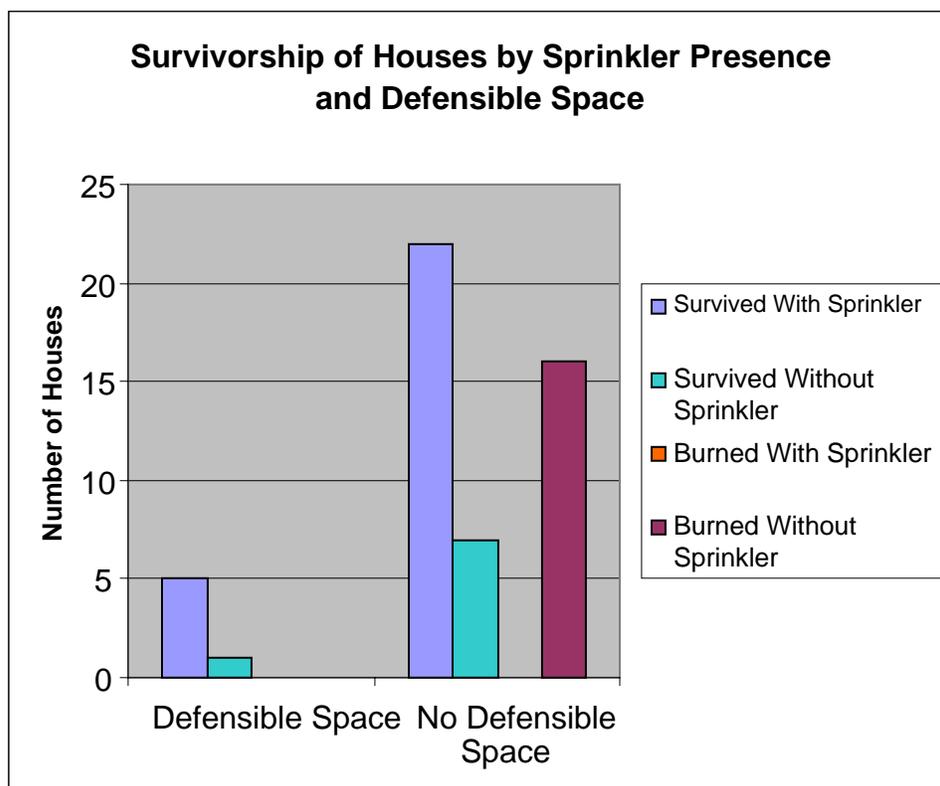
Figure 2: House survivorship by defensible space and sprinkler systems (on same axis), Ham Lake Fire, along the Gunflint Trail, 2007.

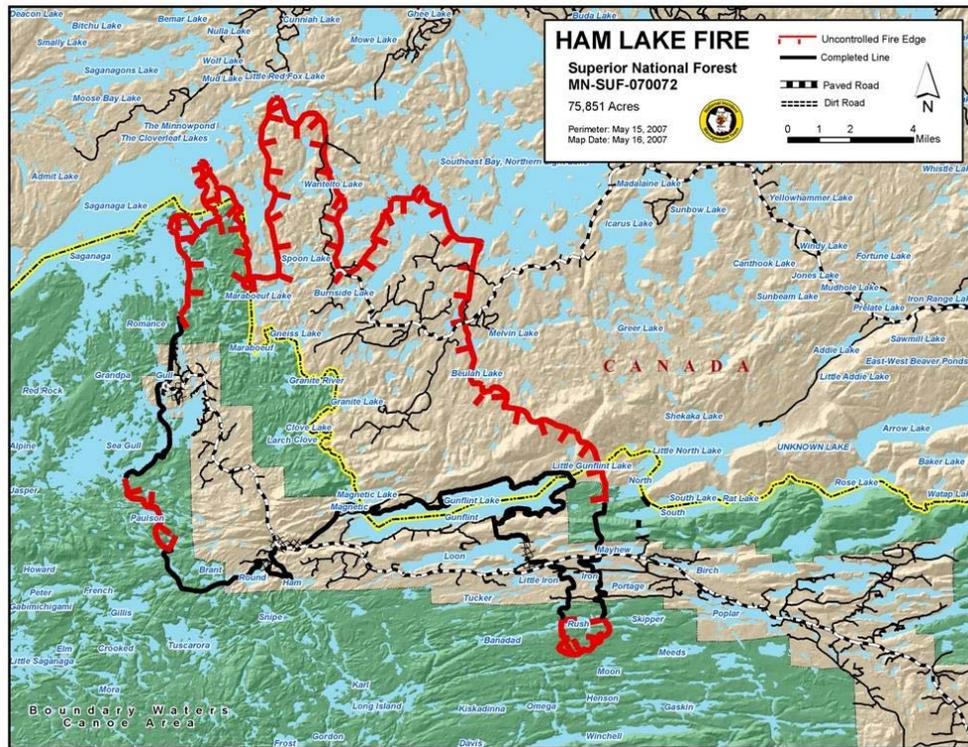
Figure A-1. Ham Lake Fire Burn Area Perimeter, Minnesota, 2007.
(source: Wildland Fire and Incident Information System. Online at www.inciweb.org/incident/maps/660. Accessed 5/30/08.)

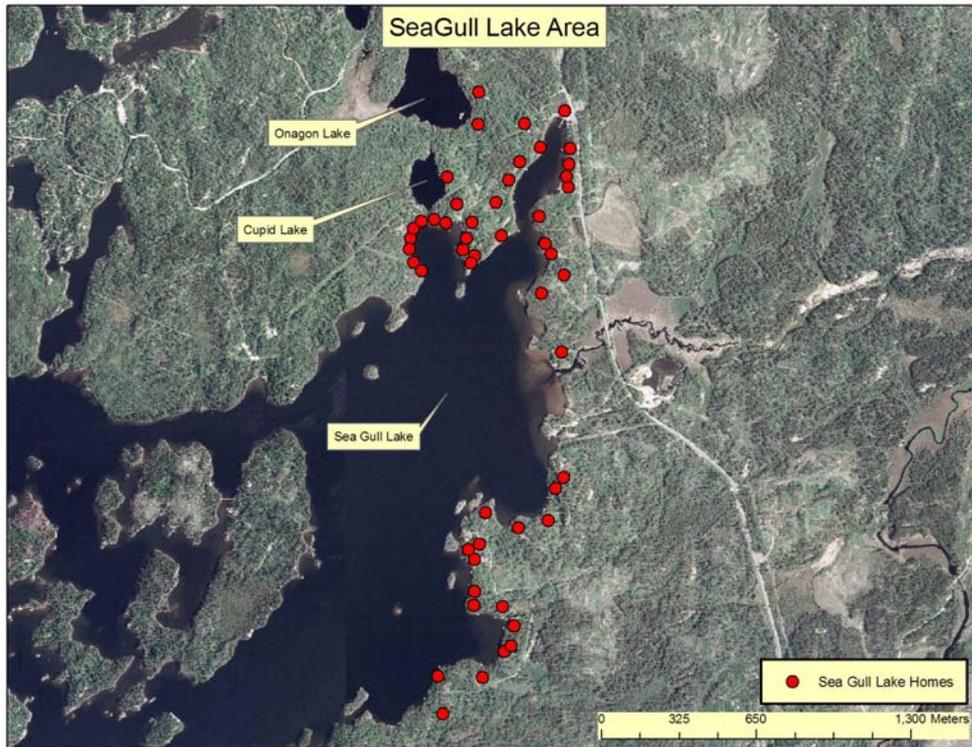
Figure A-2. Seagull Lake Study Area, Ham Lake Fire, Minnesota, 2007.
 (source: NAIP Orthophoto, Minneapolis, MN. Timothy Downing, 2008, using ArcGIS 9.2.)

Seagull Lake is in the southern region, and contains houses found along the eastern and northeastern shores of Seagull Lake, Cupid Lake, and Onagon Lake (see Appendix A, Figure A-2). These houses are on the following road segments: Seagull Lake Road, Seagull Access Road, Blankenburg Lane, Island Road, Gull Point Road, Onagon Road, and the Gunflint Trail itself. Based on the TIGER file (U.S. Census Bureau 2008), the sequence of house numbers could be determined (i.e., whether the numbers go up or down as you continue along the road), and from personal communication, certain landmark houses could be identified and matched with a given address. Then the rest were filled in by continuing up or down the road from these houses and matching addresses based on house locations. Some houses could not be found even with the GoogleEarth image, and so for these the location was approximated based on

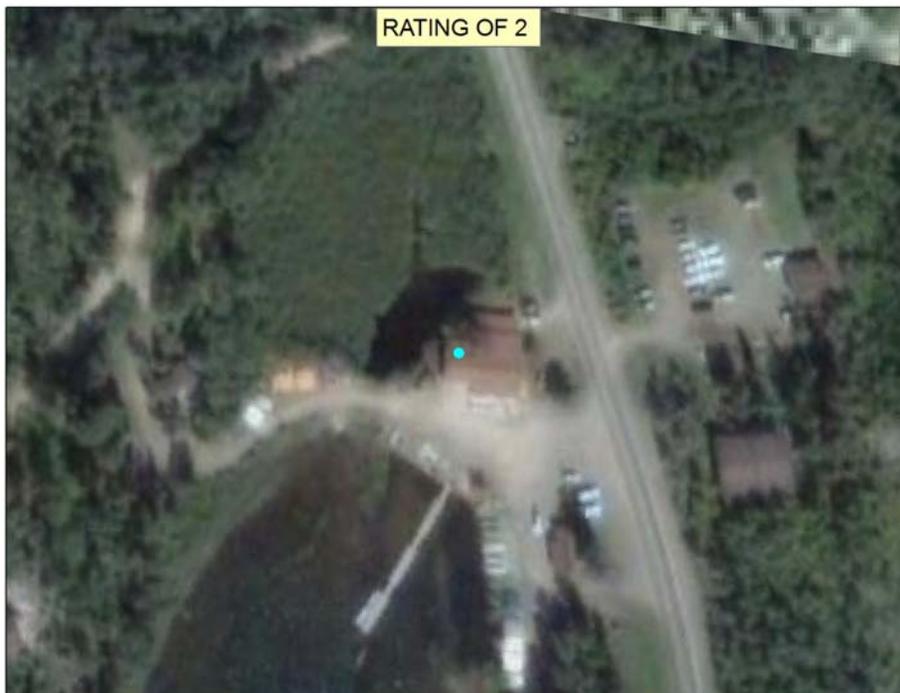
Figure A-3. Example of House Rating No. 2: This building is clearly out in the open; there are trees in the general vicinity but nothing within a house length. (source: Google Earth Imagery Digital Media. Available online at <http://earth.google.com>. Accessed 5/30/08.)

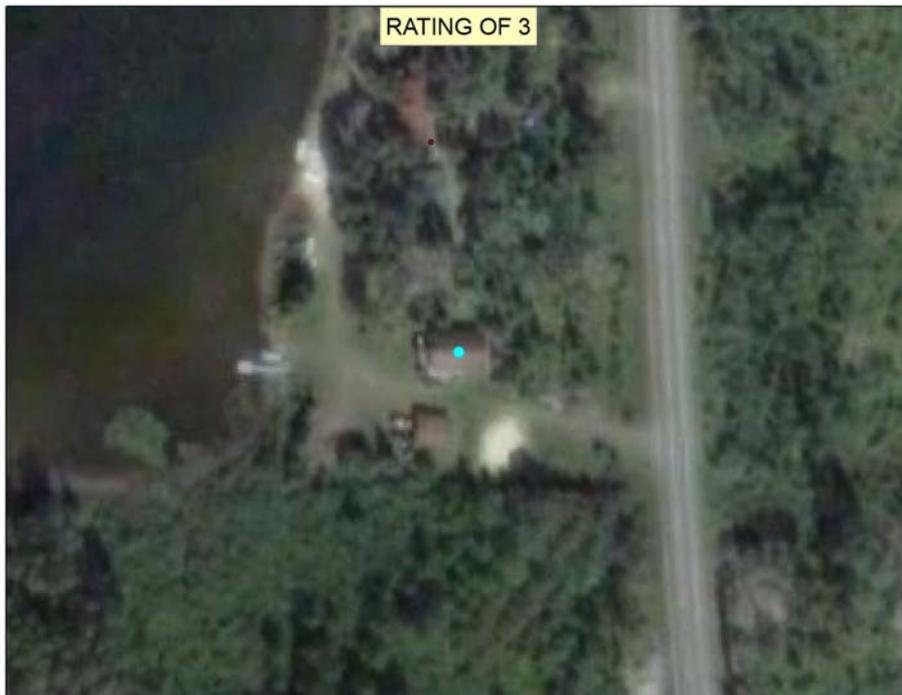
Figure A-4. Example of House Rating No. 3: This building is generally in a clearing, but there are trees on the north side that are within 1 house length. (source: Google Earth Imagery Digital Media. Available online at <http://earth.google.com>. Accessed 5/30/08.)

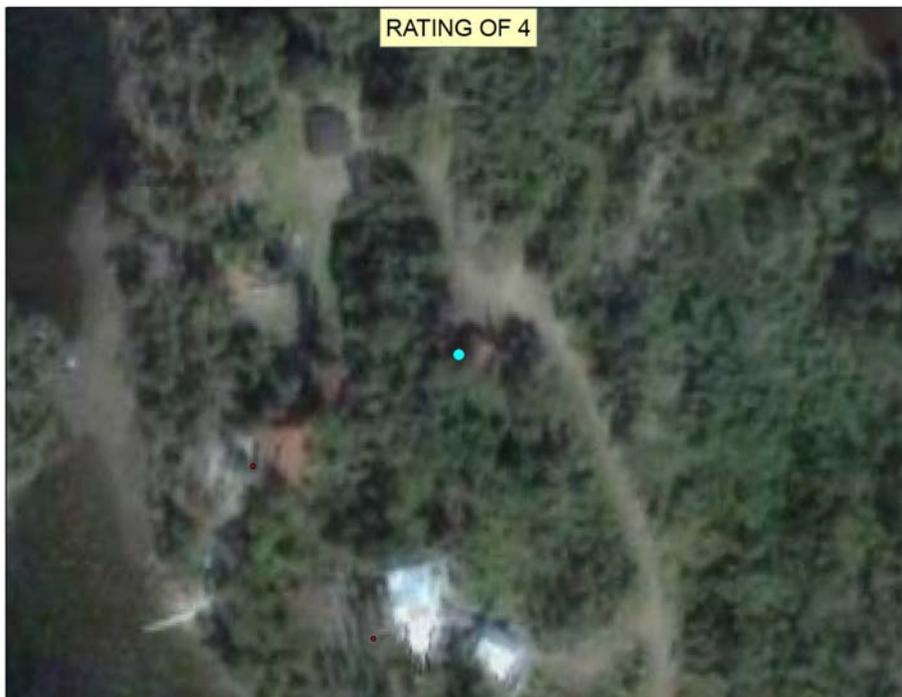
Figure A-5. Example of House Rating No. 4: This building is obscured to the south by trees, but there is a large cleared patch to the north. (source: Google Earth Imagery Digital Media. Available online at <http://earth.google.com>. Accessed 5/30/08.)

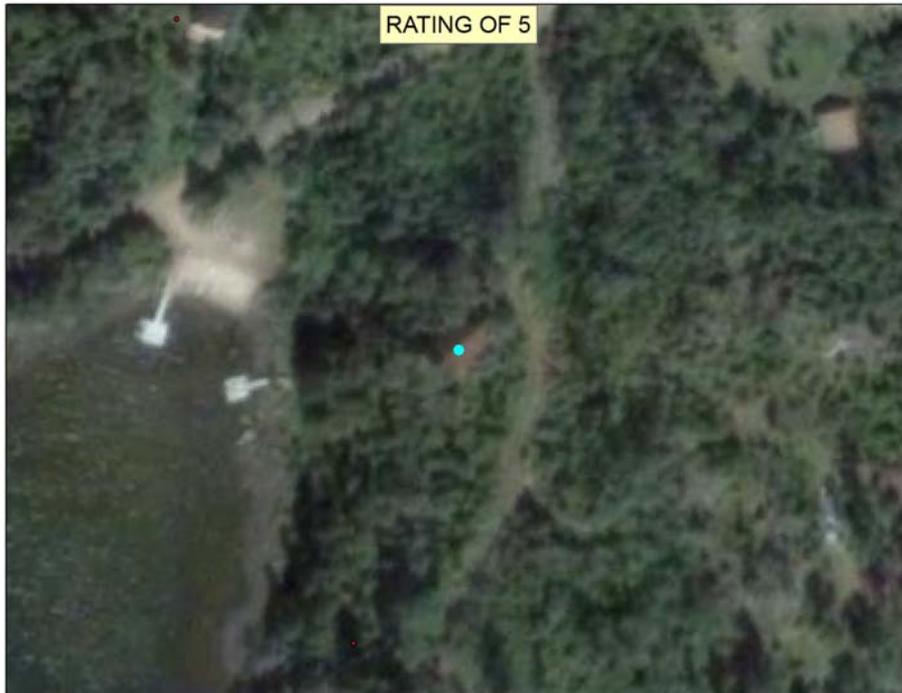
Figure A-6. Example of House Rating No. 5: This building is completely enclosed by trees on all four sides. (source: Google Earth Imagery Digital Media. Available online at <http://earth.google.com>. Accessed 5/30/08.)

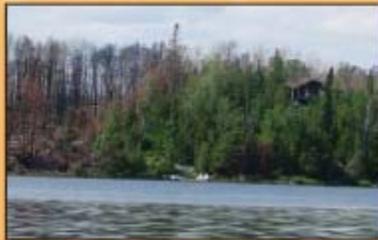
Shoreline of Seagull Lake where intense fire burned up to vegetation. Sprinklers protected the cabin and the surrounding vegetation.

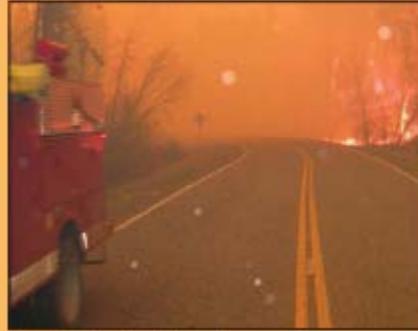
Fire on the Gunflint Trail during evacuation.

In May 2007, a fast wind-driven wildfire overtook homes and cabins in northeastern Minnesota. Many properties were destroyed by the fire. Of 104 homes, cabins, or major structures that were hit by the fire, 39 were destroyed. Of the 65 that survived, 46 had working external sprinkler systems. Some homes without sprinklers survived because they had good defensible space. One home with a working sprinkler system was lost.

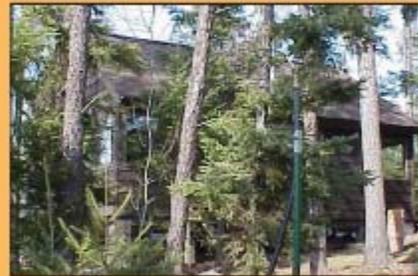
This cabin on Seagull Lake was protected by its working sprinkler system during the May 2007 wildfire. The cabins on both sides of this cabin did not have sprinkler systems and were destroyed in the fire.

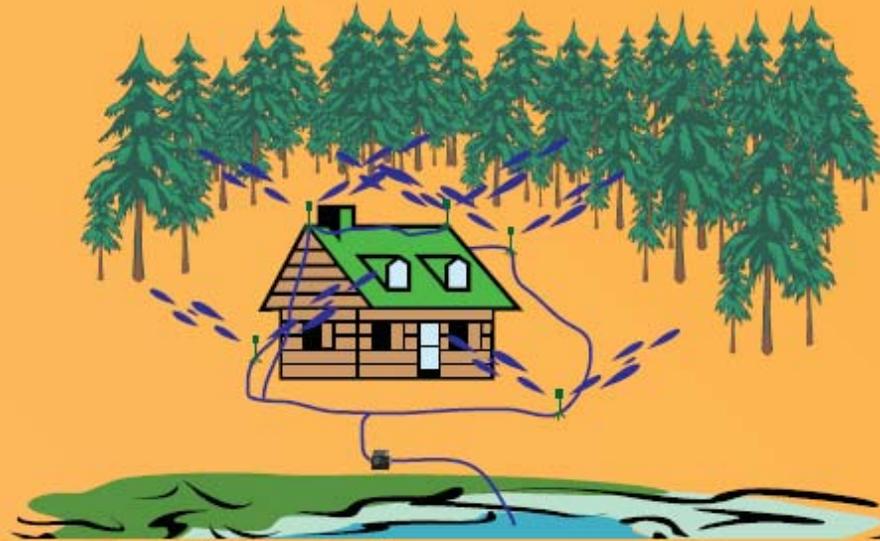
An illustration of an external wildfire sprinkler system.

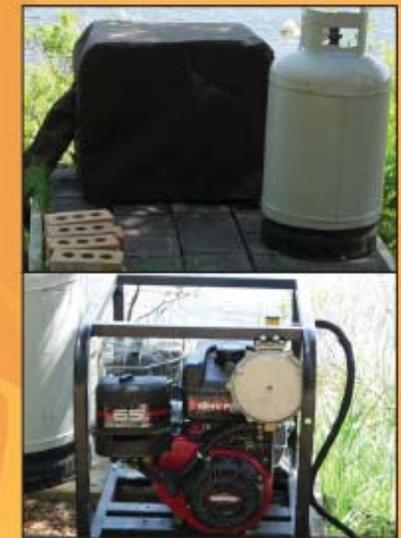
(Top) Example of a covered pump. (Bottom) Example of an uncovered pump.

As seen in these photos, sprinkler heads and hoses can be relatively hidden in existing vegetation, and pumps should be kept covered when not in use. Many homeowners have made the decision that the extra protection offered by sprinkler systems is worth it.
